Situation Photo Log

Tuesday, May 1, 2012

Kalamazoo River / Enbridge Spill

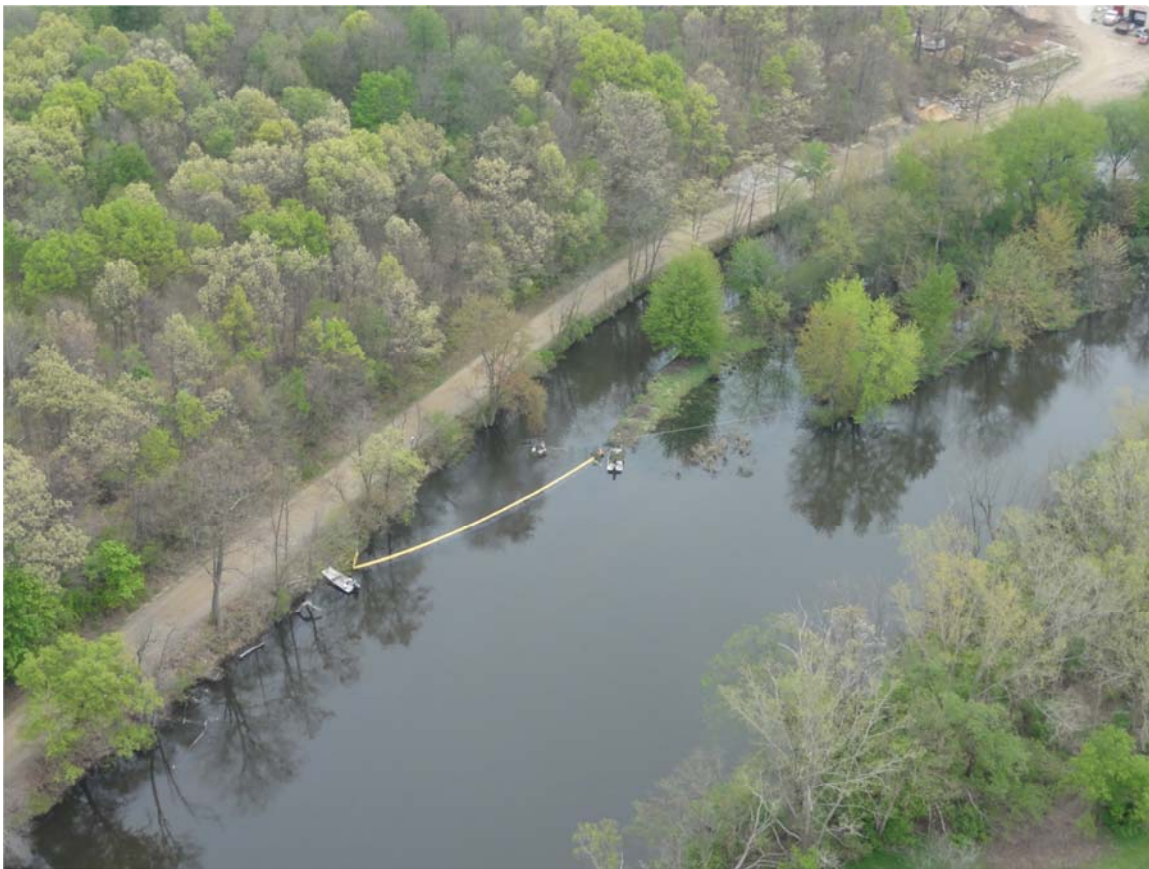
24. MP14.75 observed crew installing sediment trap.

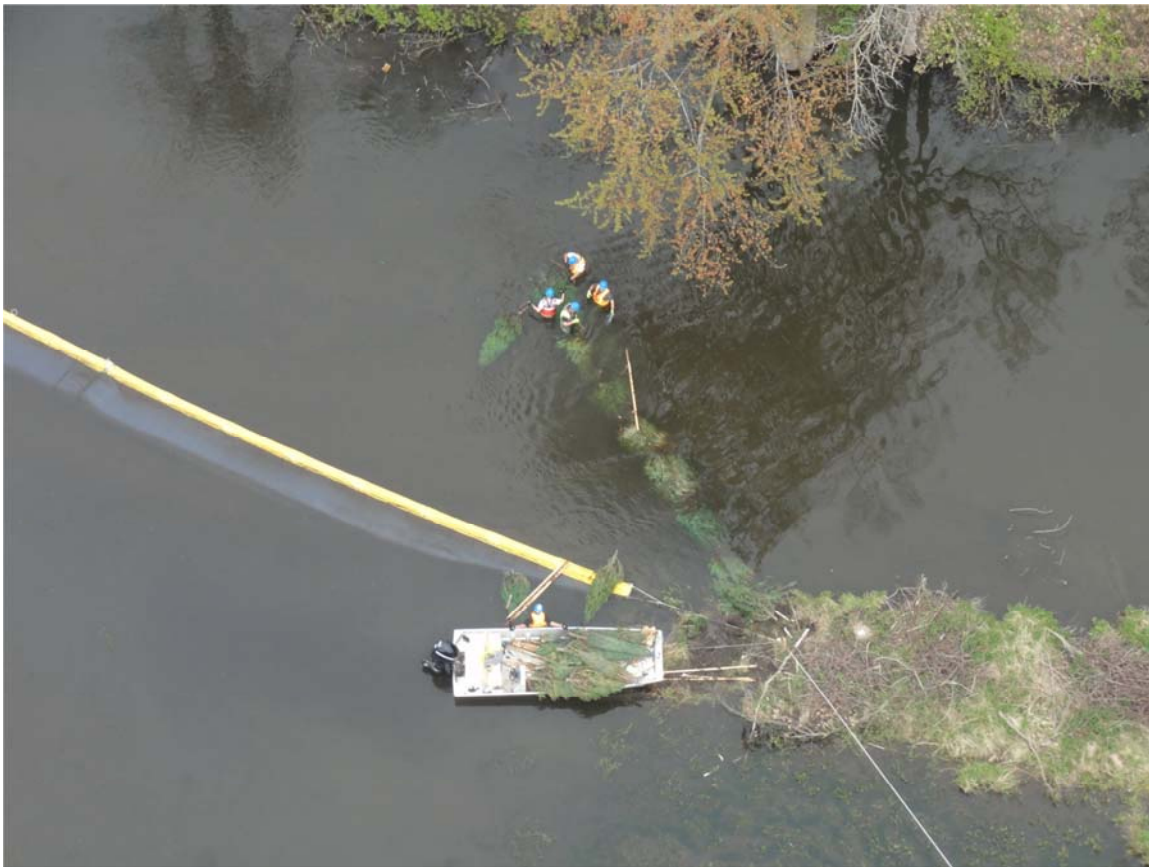
25. MP14.75 observed crew installing sediment trap.

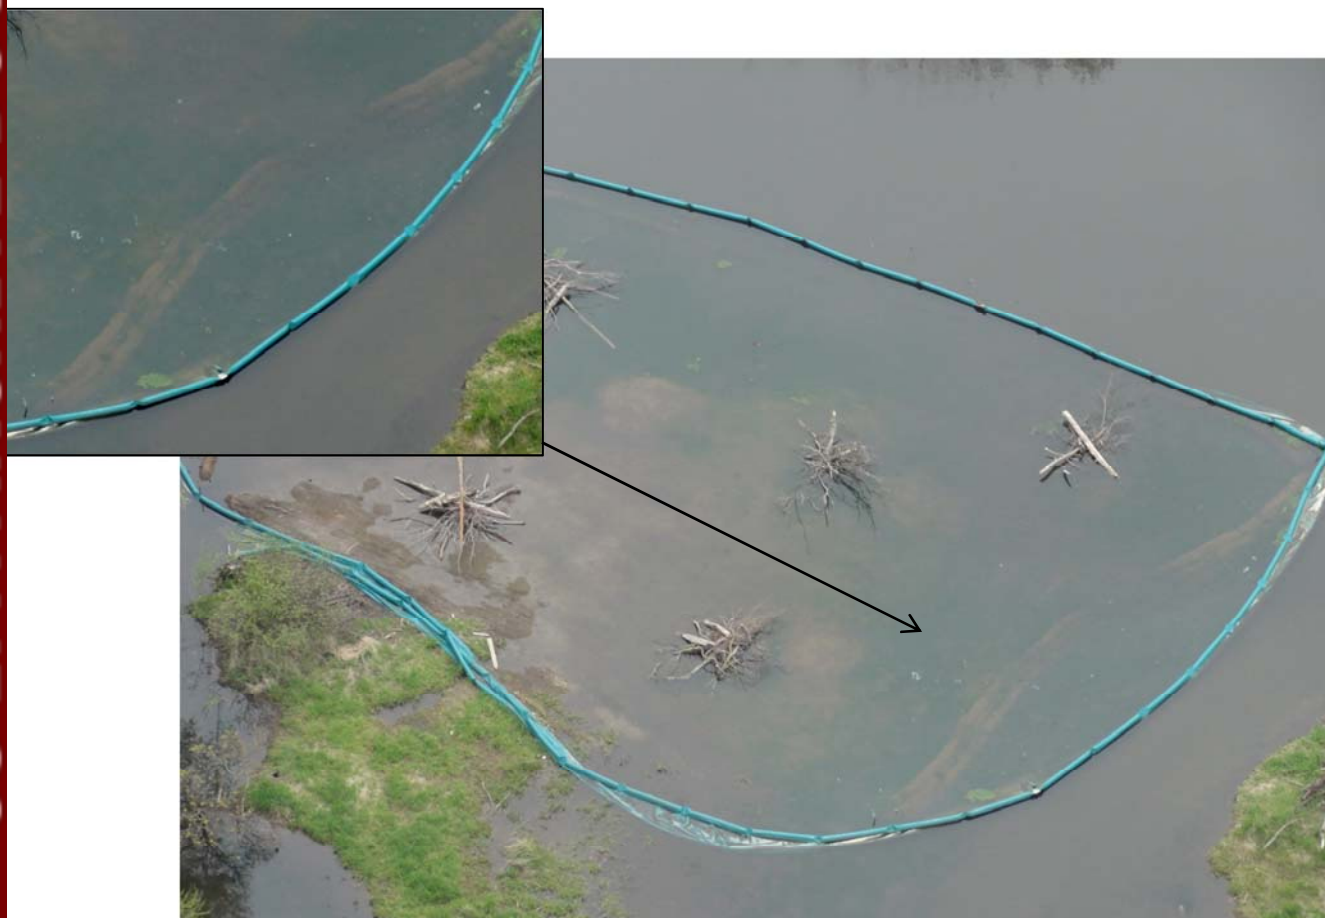
26. MP14.97 excavated island sheen observed.

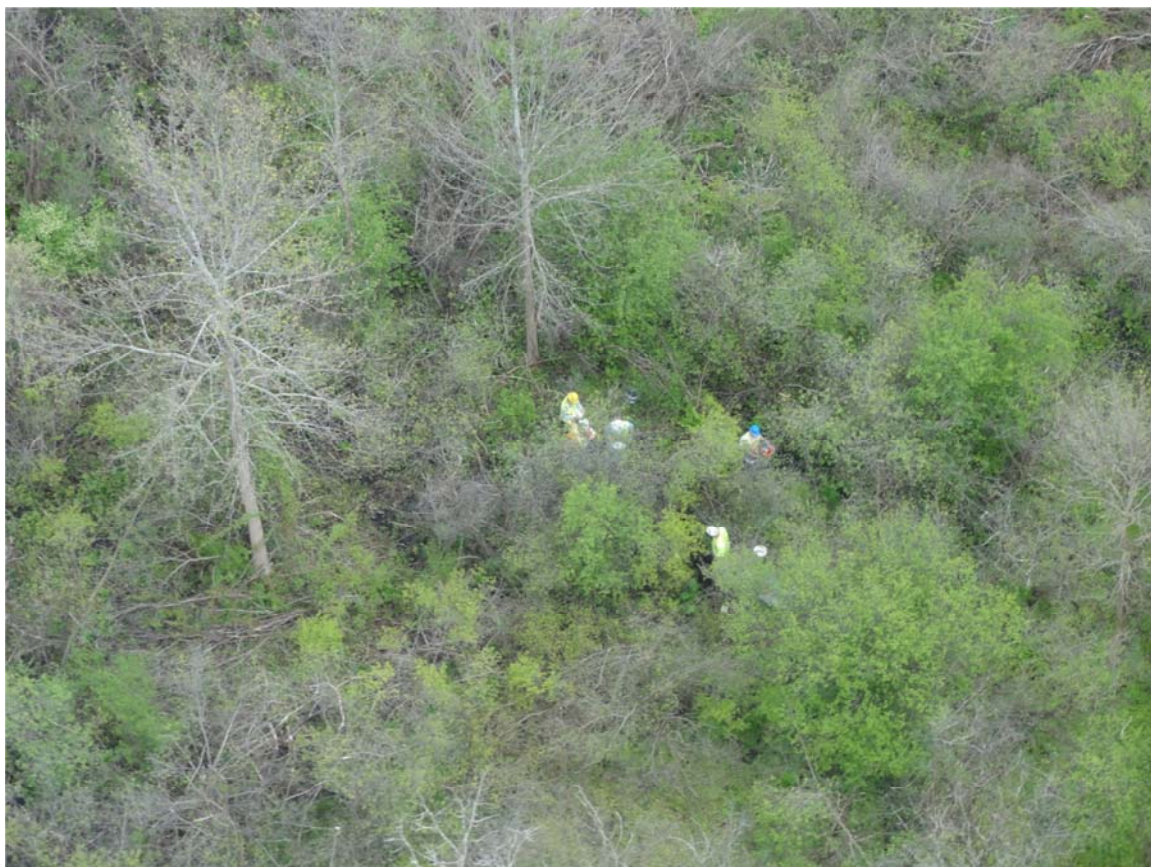
27. MP15.0 RI crew observed.

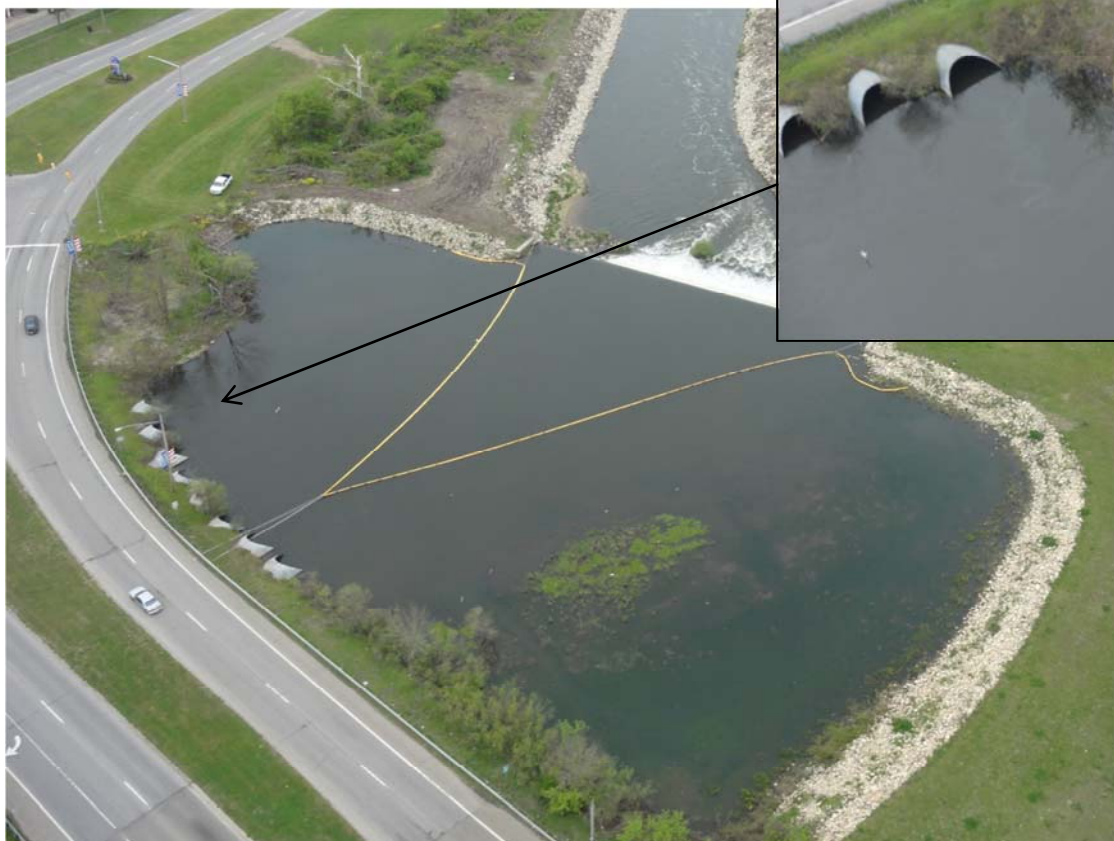
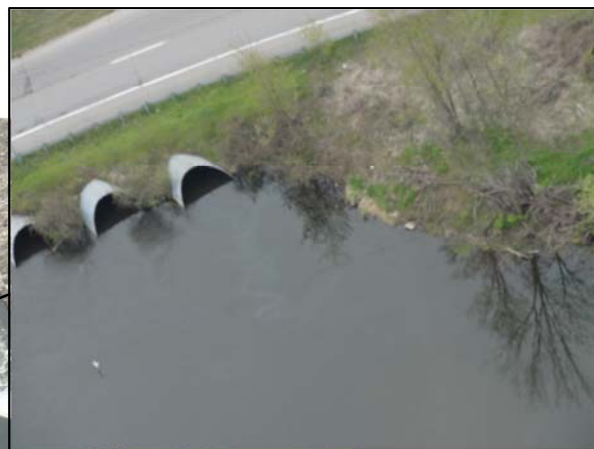
28. MP15.75 sheen observed coming through culvert.

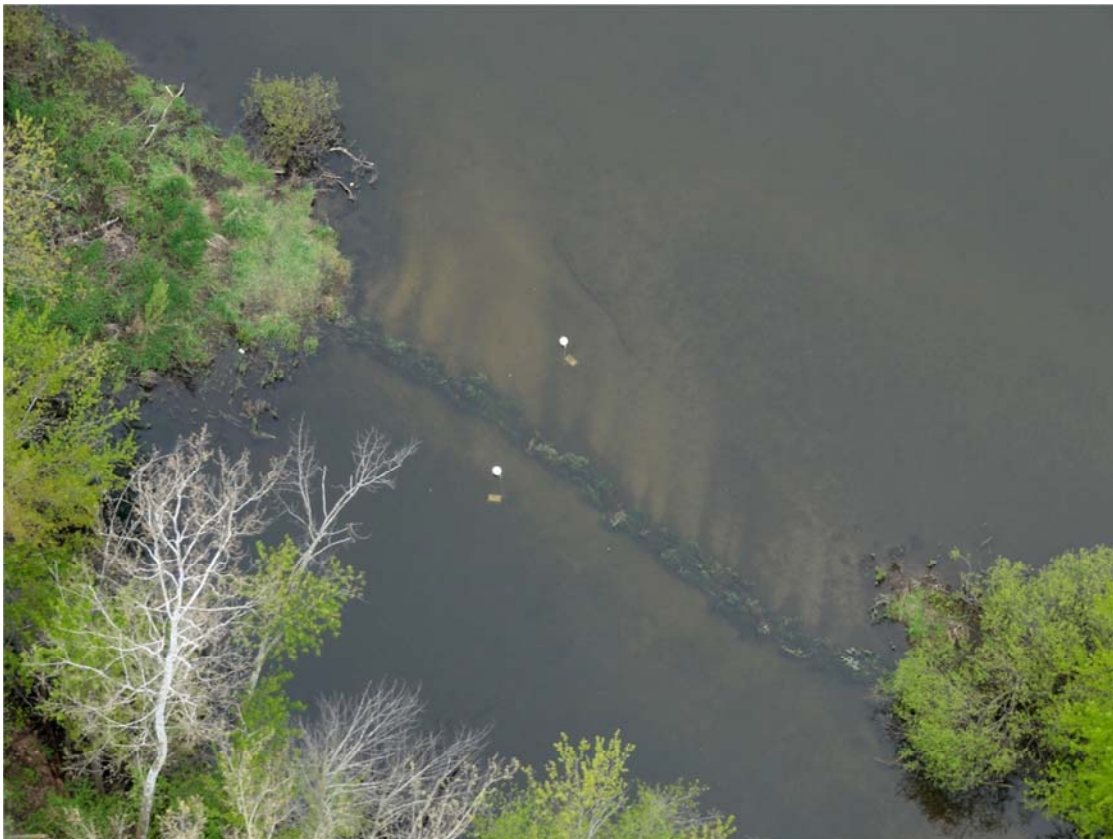
29. MP19.25 sediment control structure #1.

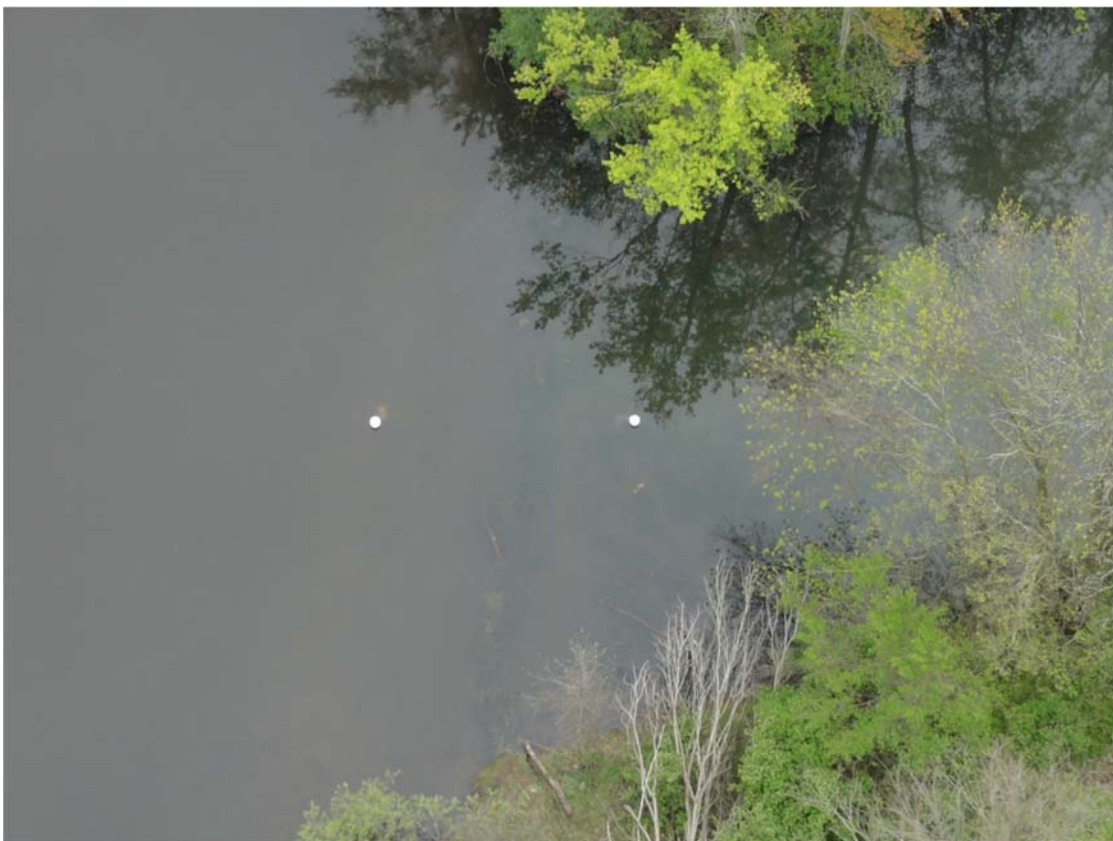
30. MP19.25 sediment control structure #2.

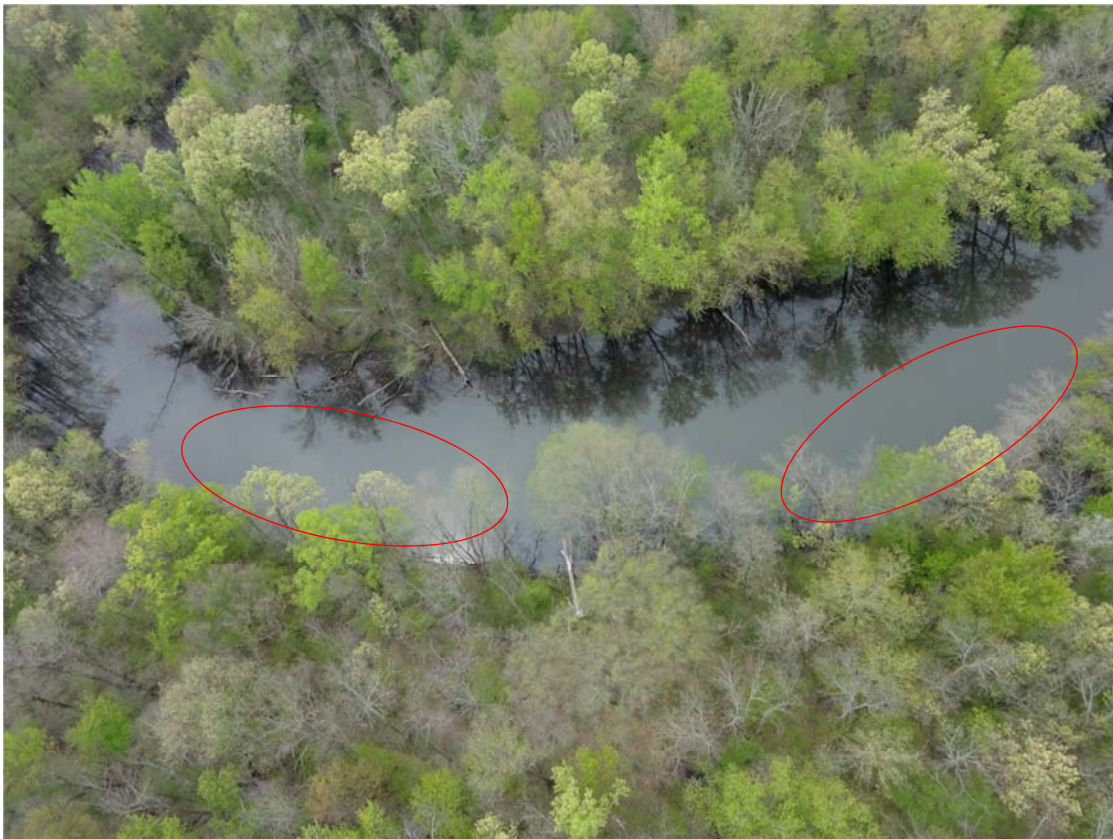
31. MP22.25 RDB sheen observed.

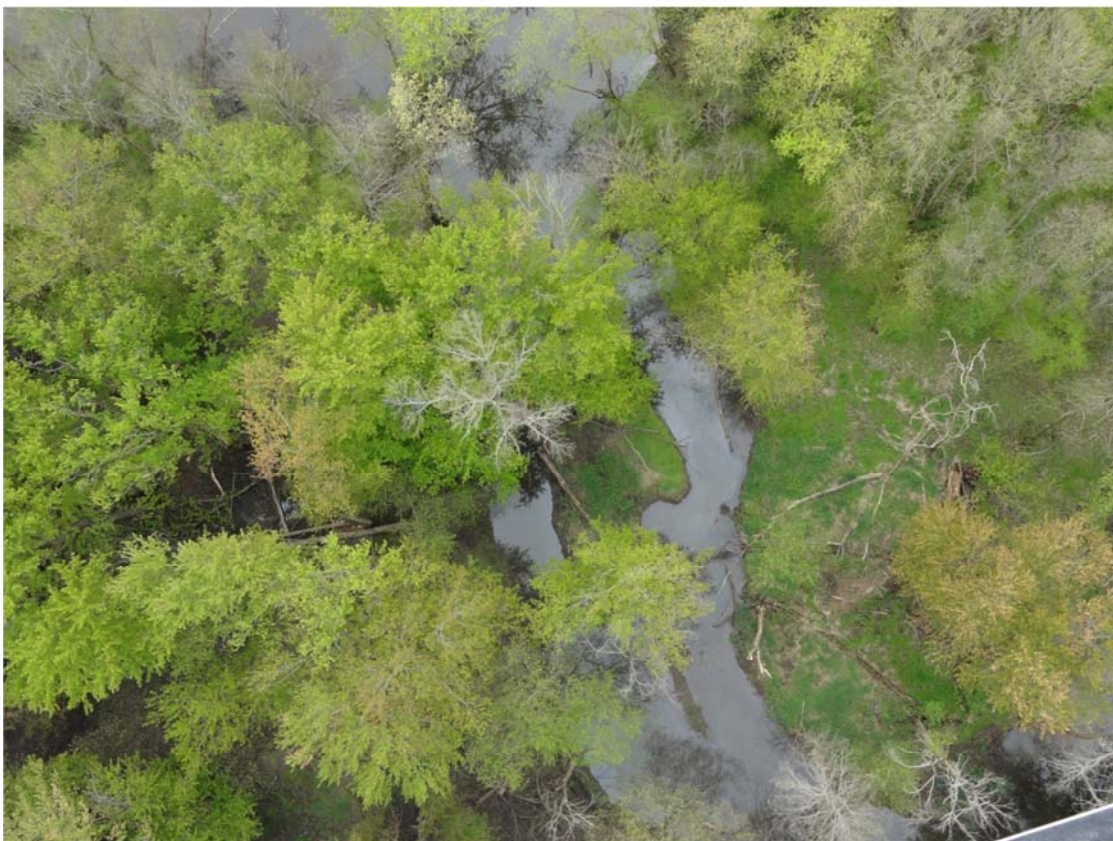
32. MP22.5 RDB sheen observed.

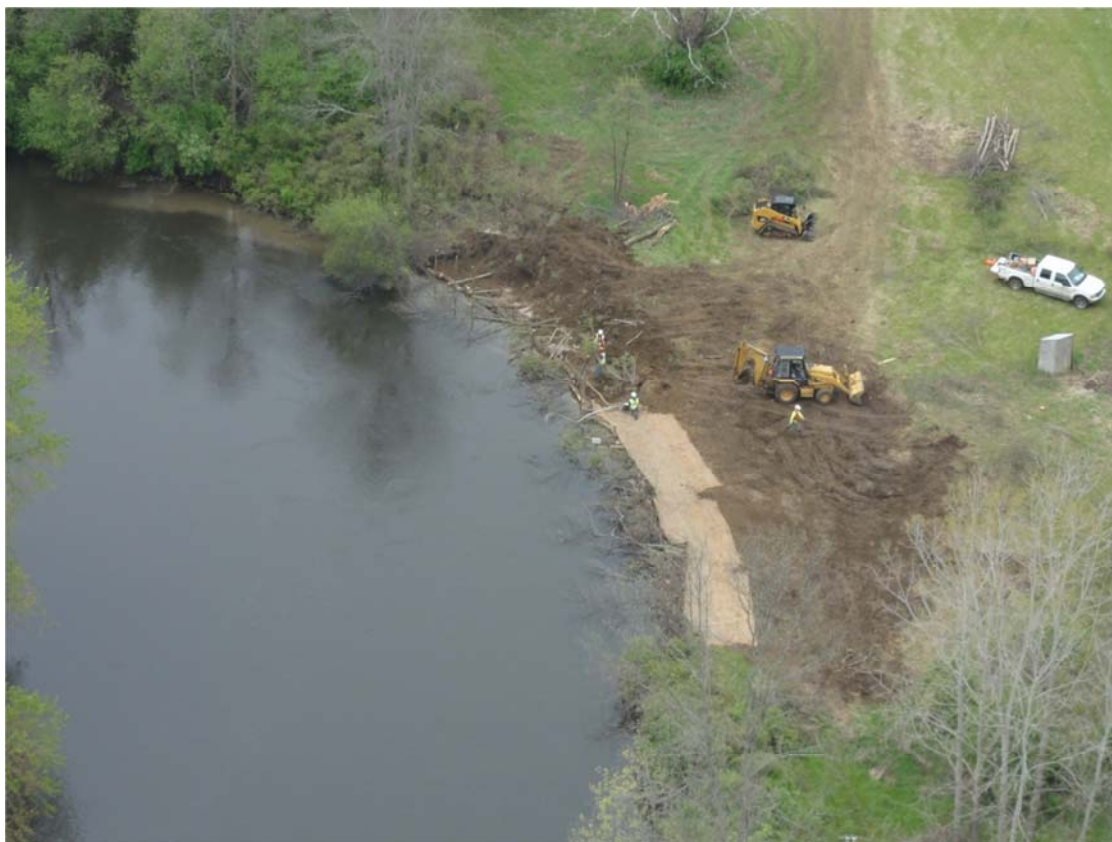
33. MP24.0 shoreline restoration work.

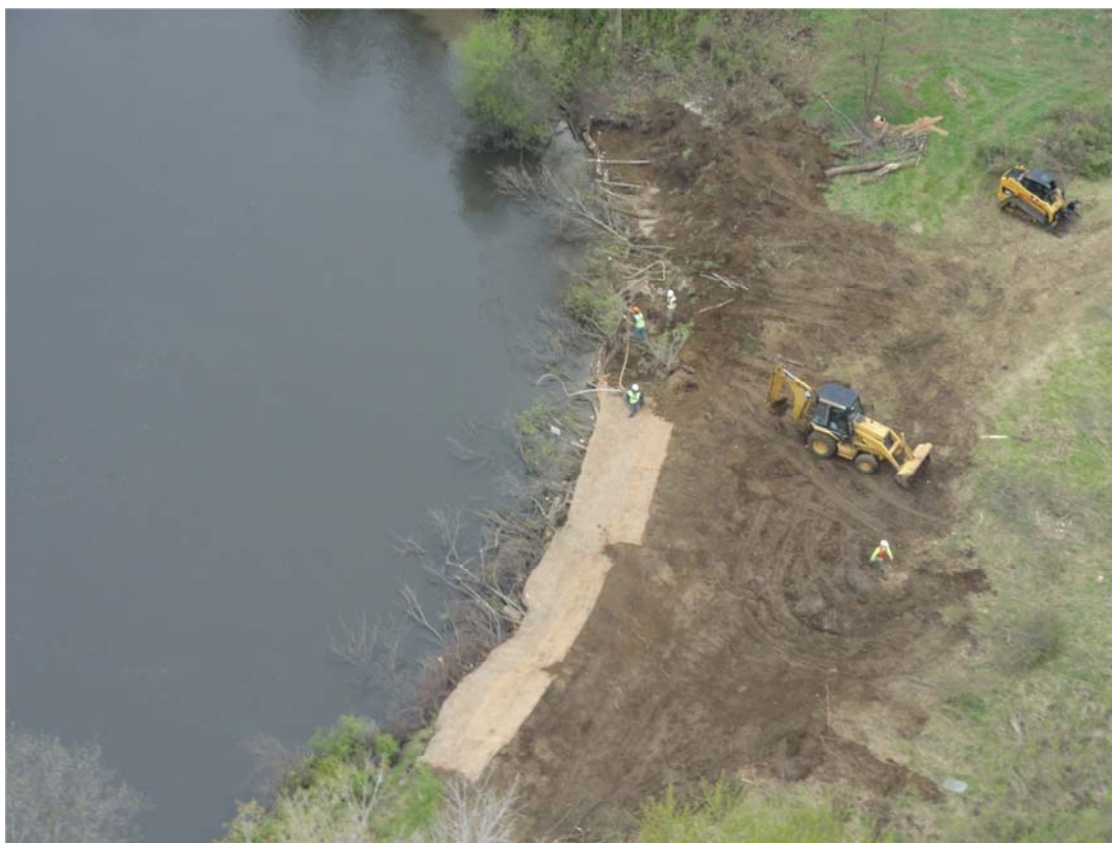
34. MP24.0 shoreline restoration work.

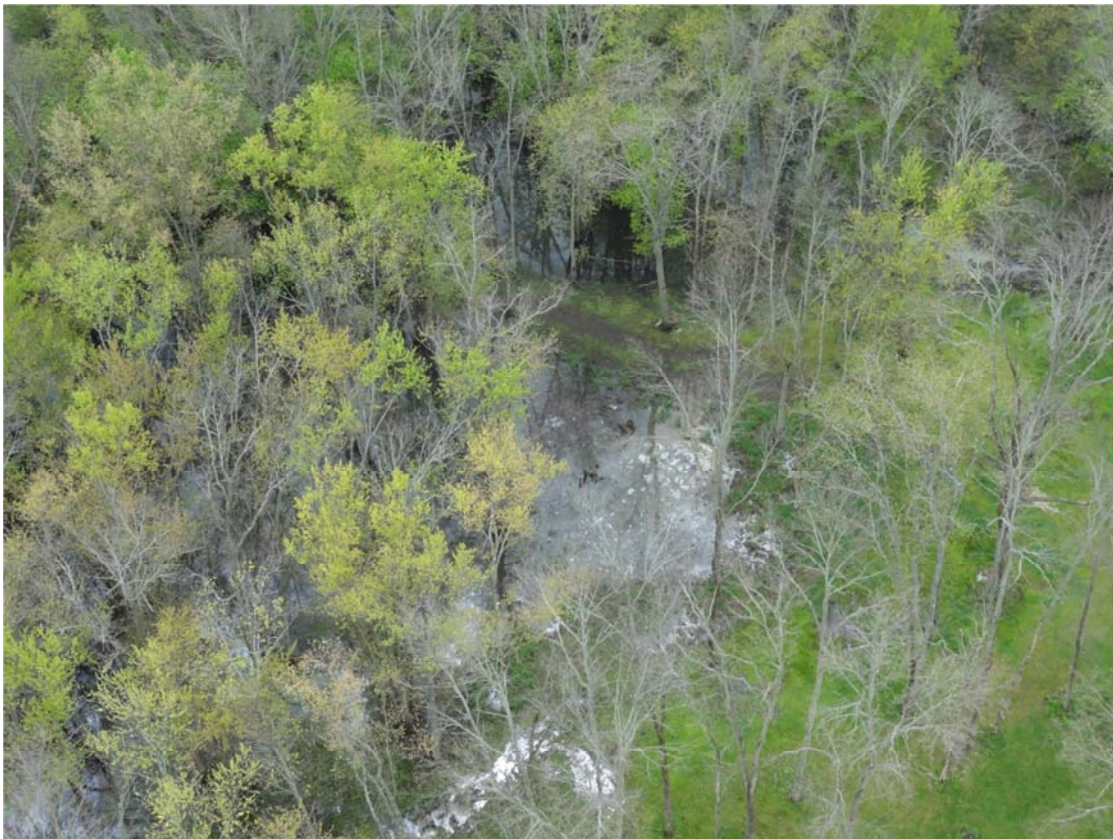
35. MP27.0 RDB sheen observed.

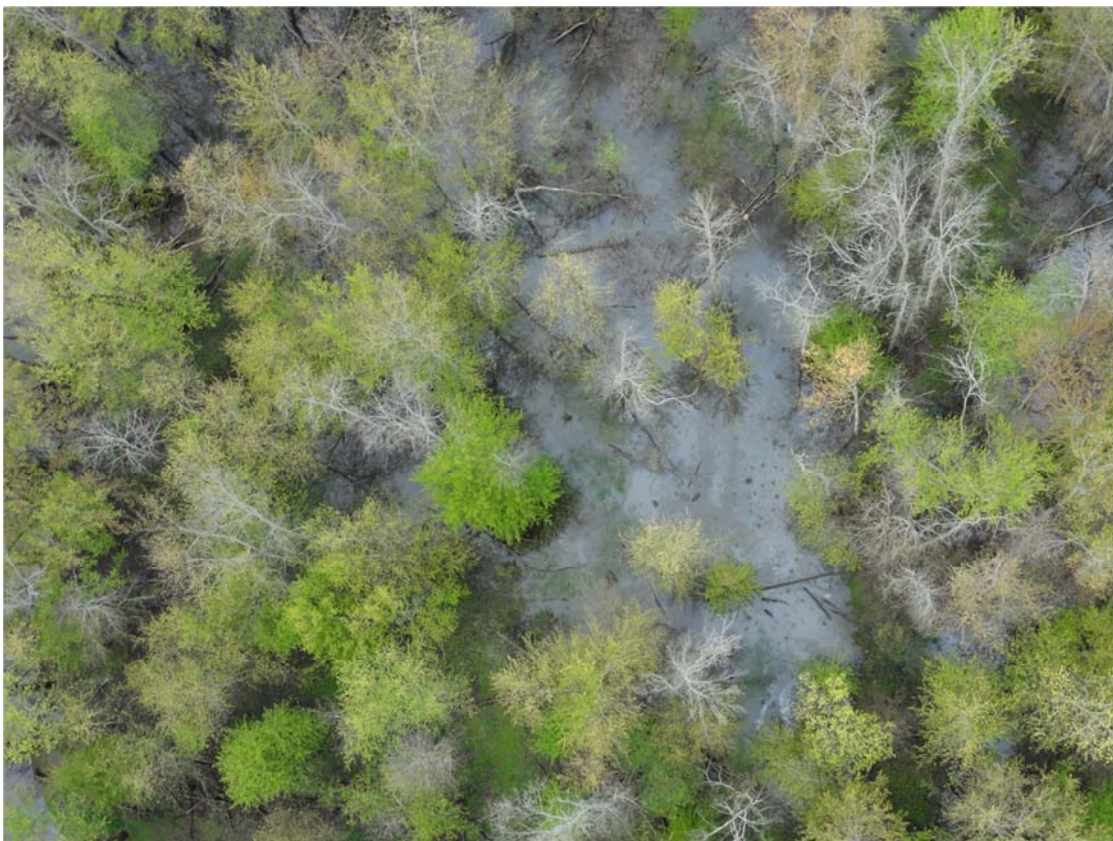
36. MP28.75 RDB sheen observed overbank area.

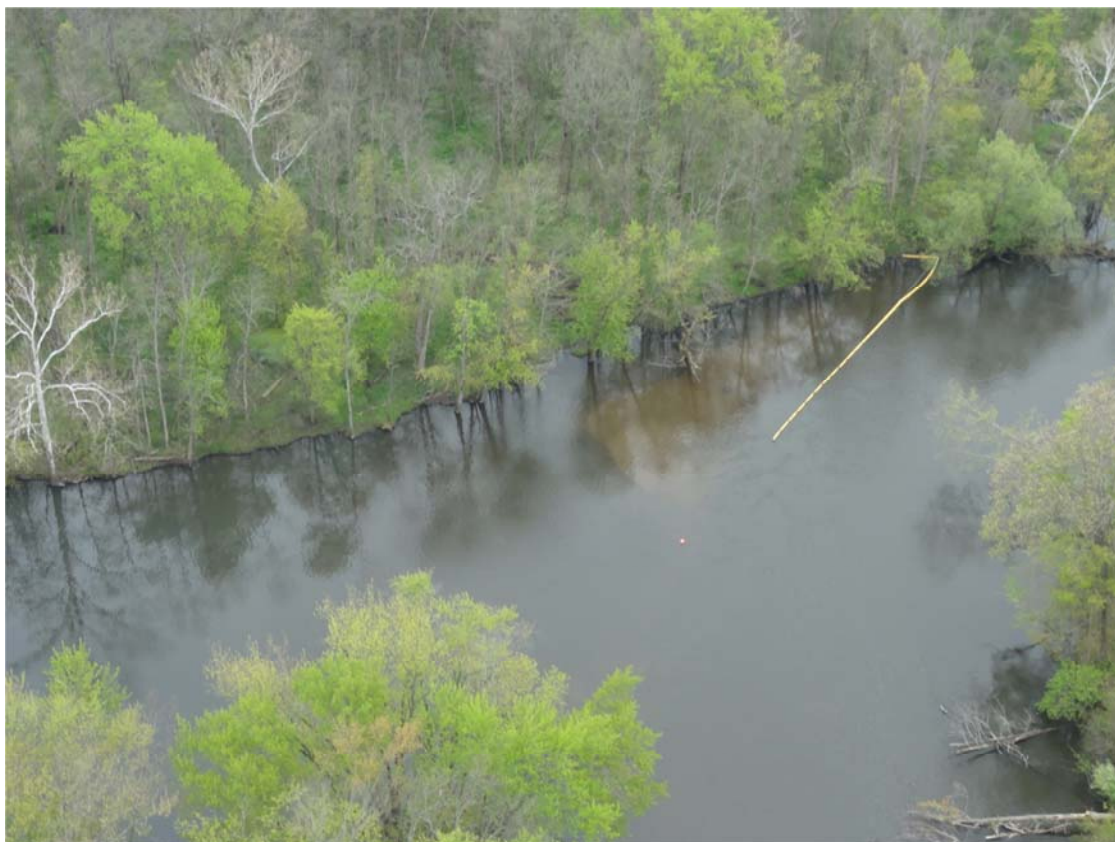
37. MP30.9 containmnet boom no sheen observed.

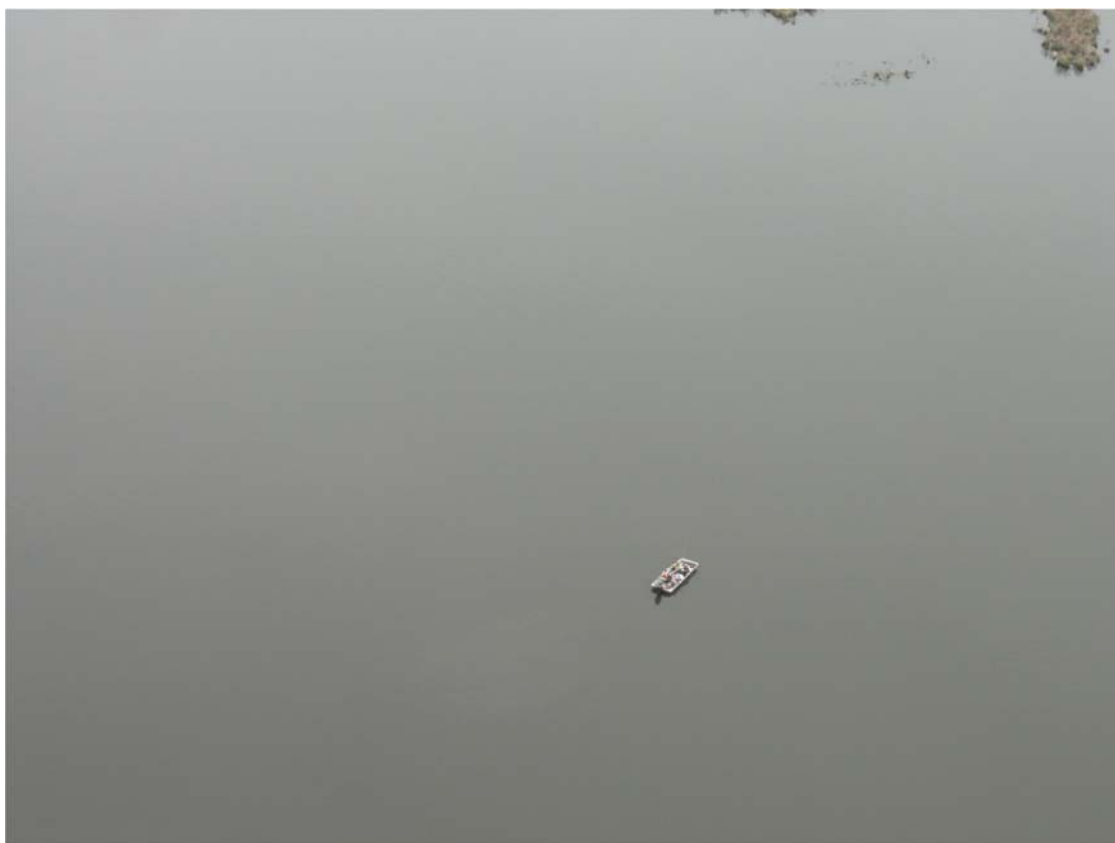
38. Morrow Lake Delta poling.

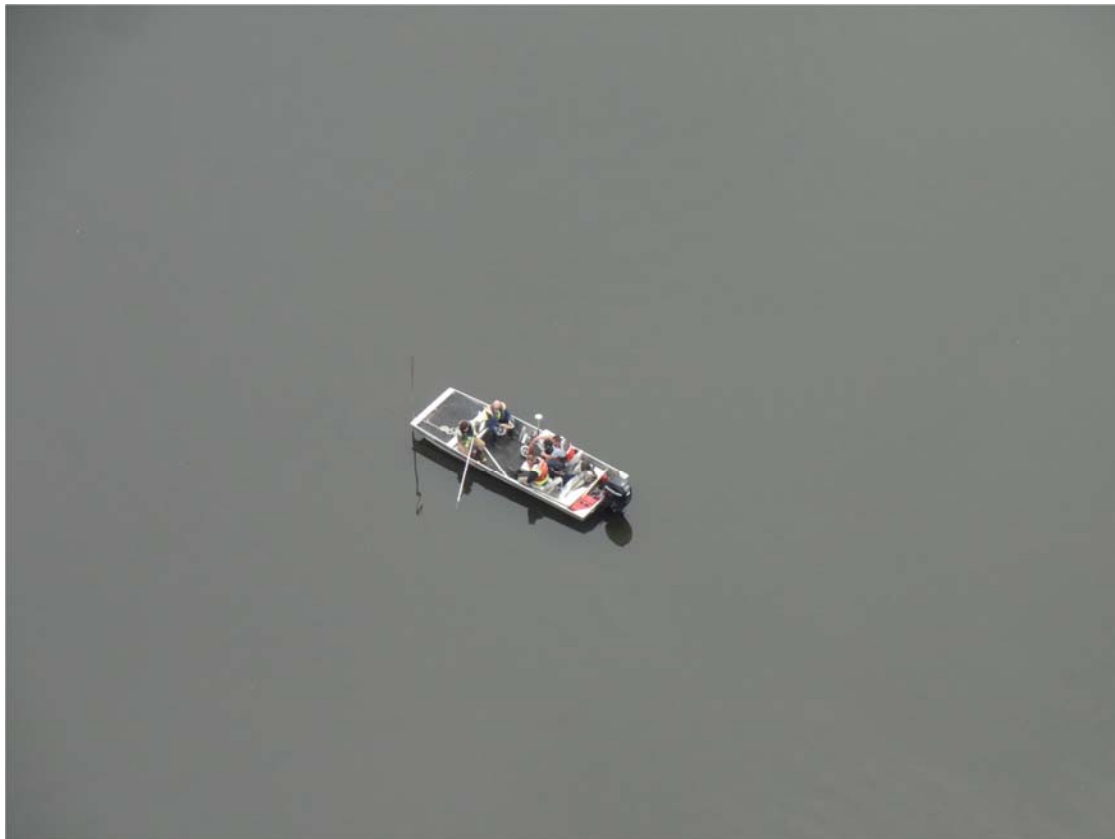
39. Morrow Lake Delta poling.

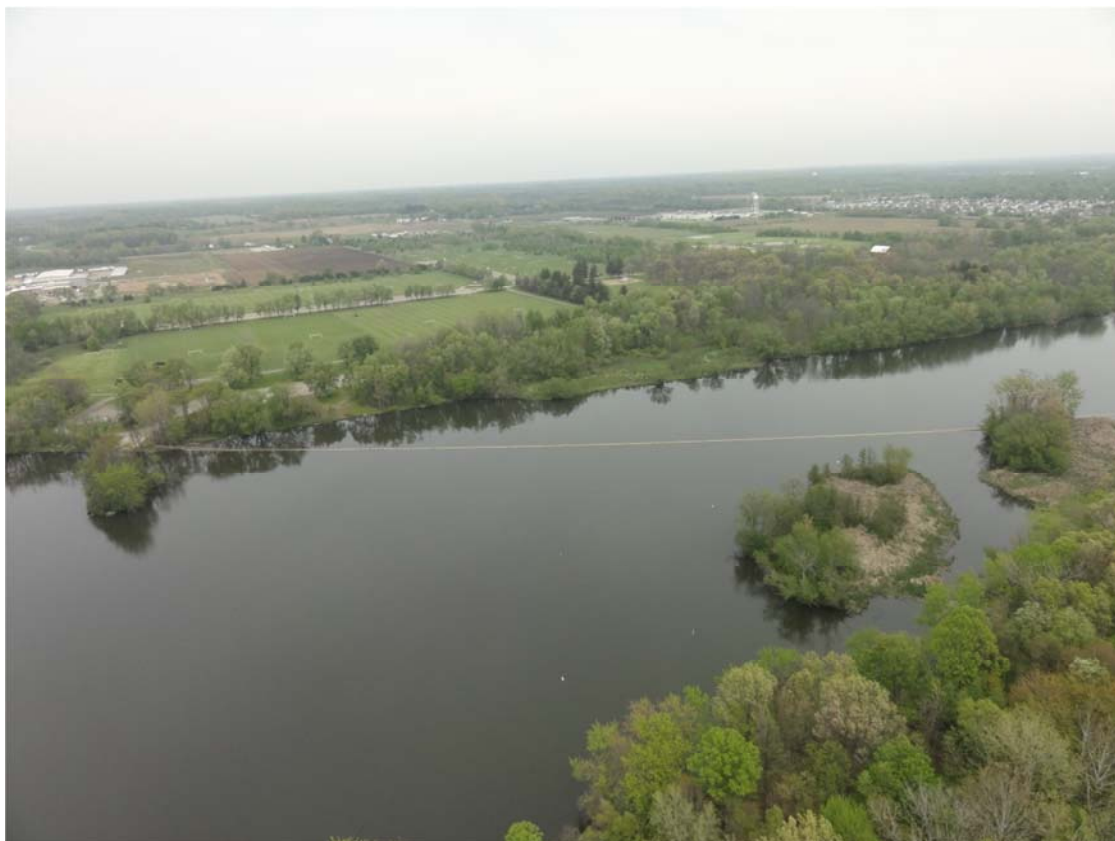
40. E4 control point no sheen observed.

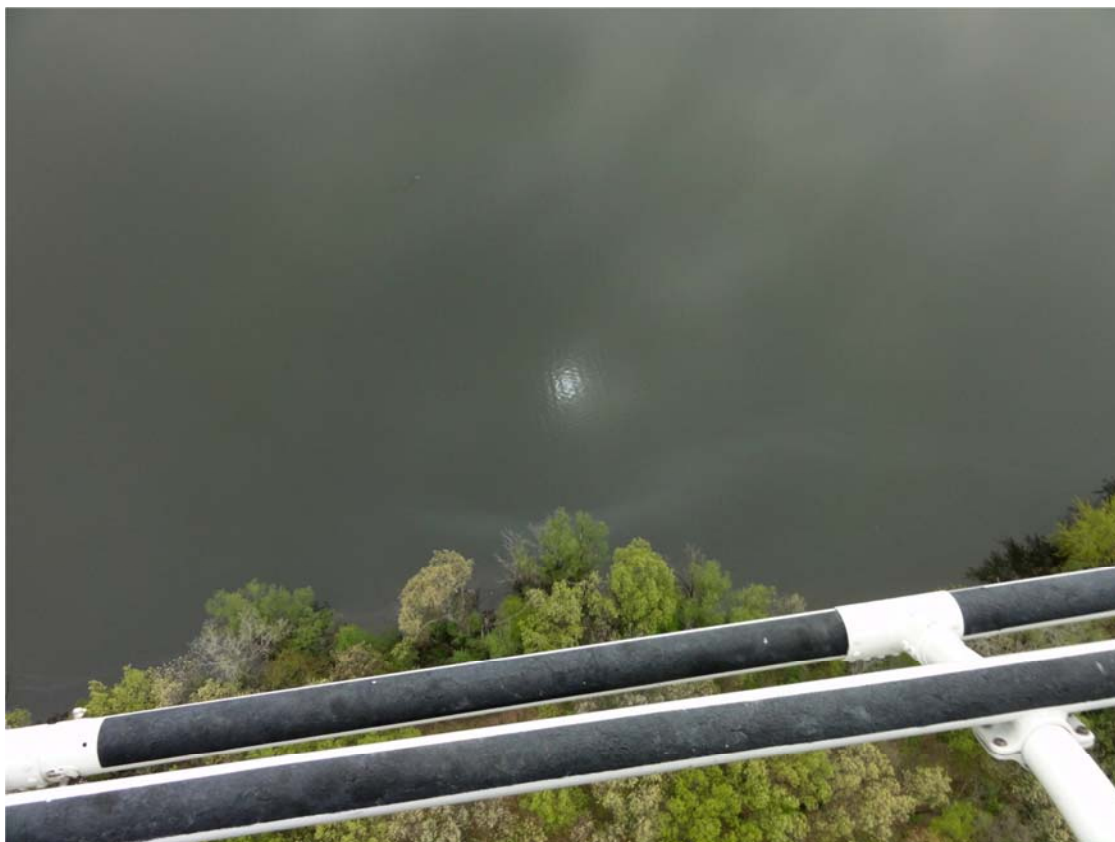
41. Morrow Lake sheen observed along the north shoreline.

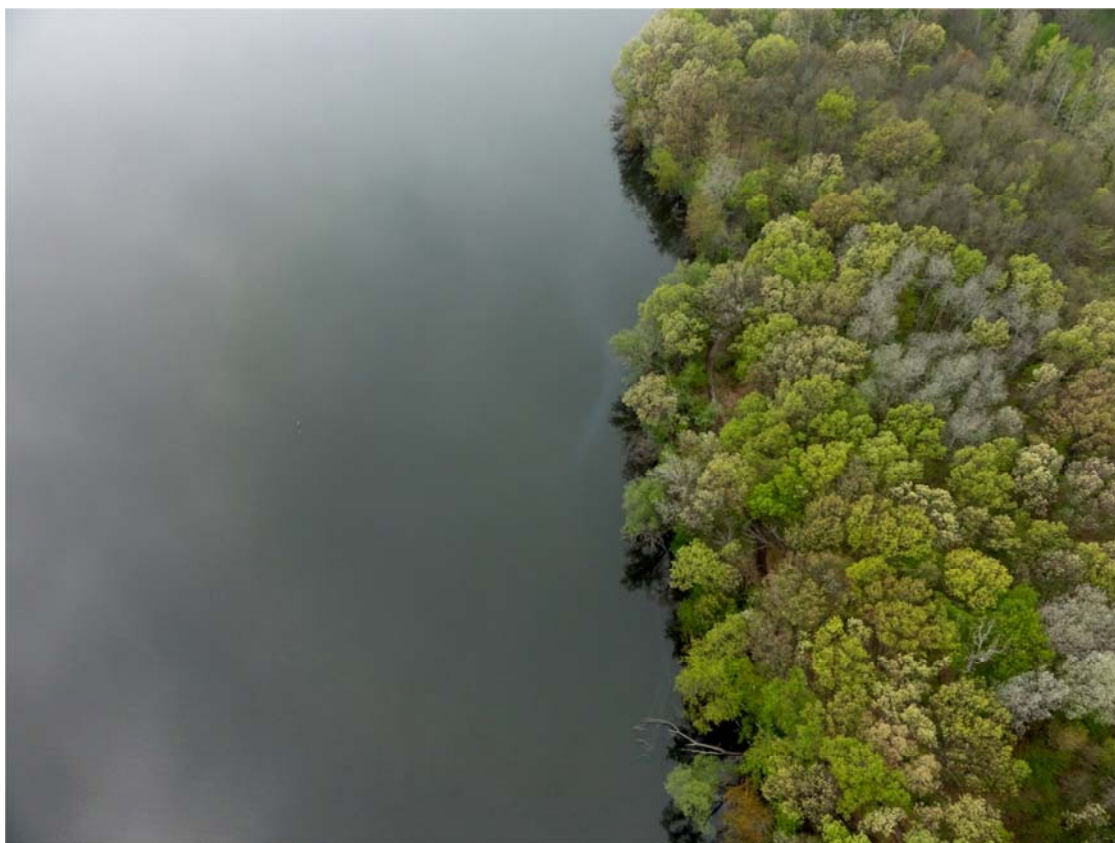
42. Morrow Lake sheen observed along the north shoreline.

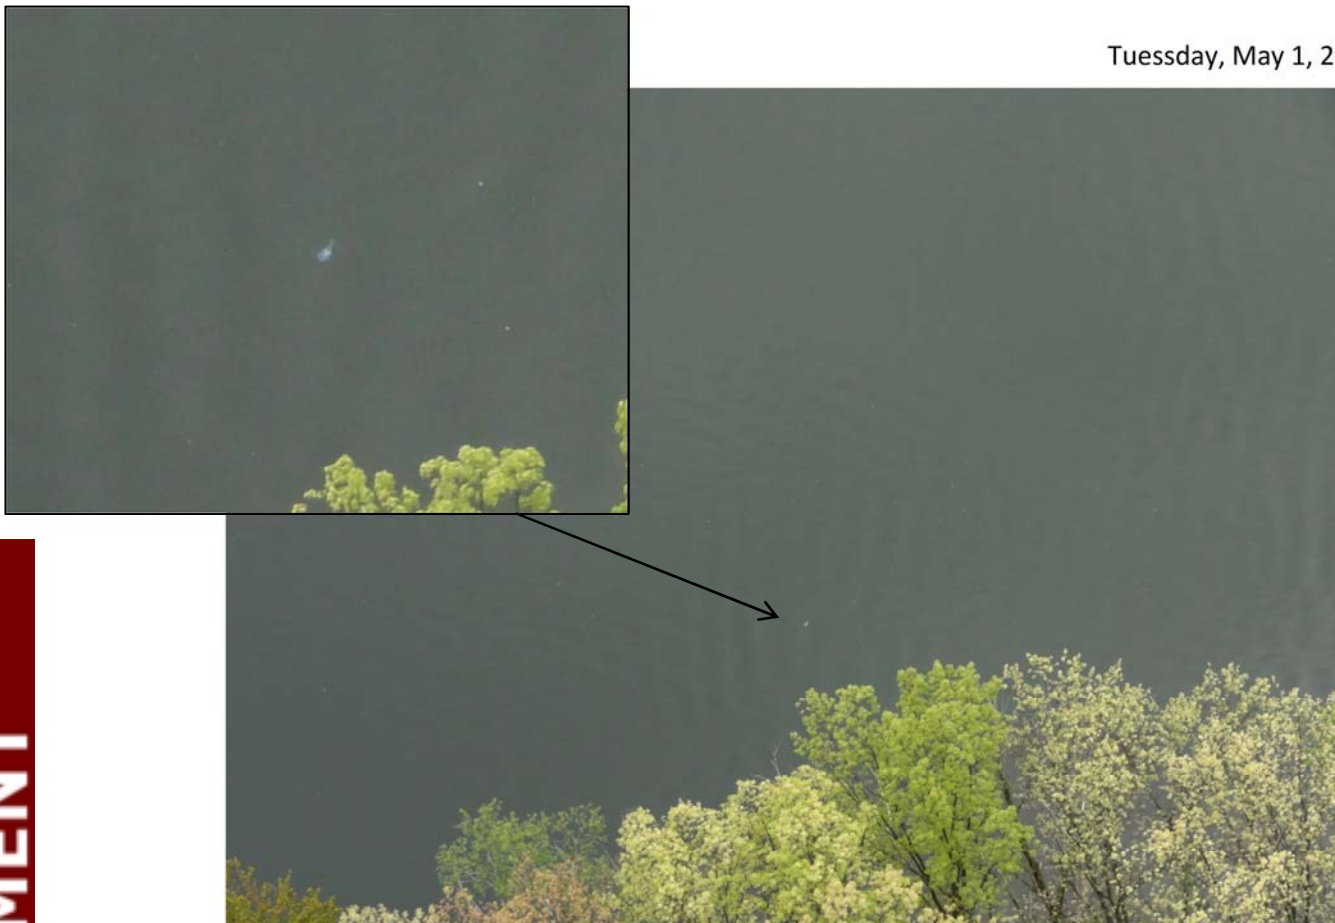
43. Morrow Lake sheen observed along the north shoreline.
